DEPARTMENT OF TRANSPORTATION**DIVISION OF ENGINEERING SERVICES**

Contract #: 04-0120F4Cty: SF/Ala Rte: 80 PM: 13.2/13.9File #: 69.28**WELDING INSPECTION REPORT****Resident Engineer:** Siegenthaler, Peter**Address:** 333 Burma Road**City:** Oakland, CA 94607**Report No:** WIR-018704**Date Inspected:** 12-Dec-2010**Project Name:** SAS Superstructure**OSM Arrival Time:** 1900**Prime Contractor:** American Bridge/Fluor Enterprises, a JV**OSM Departure Time:** 700**Contractor:** Zhenhua Port Machinery Company, Ltd (ZPMC), Changxing Island **Location:** Shanghai, China**CWI Name:** See below**CWI Present:** Yes No**Inspected CWI report:** Yes No N/A**Rod Oven in Use:** Yes No N/A**Electrode to specification:** Yes No N/A**Weld Procedures Followed:** Yes No N/A**Qualified Welders:** Yes No N/A**Verified Joint Fit-up:** Yes No N/A**Approved Drawings:** Yes No N/A**Approved WPS:** Yes No N/A**Delayed / Cancelled:** Yes No N/A**Bridge No:** 34-0006**Component:** OBG and Tower Components**Summary of Items Observed:**

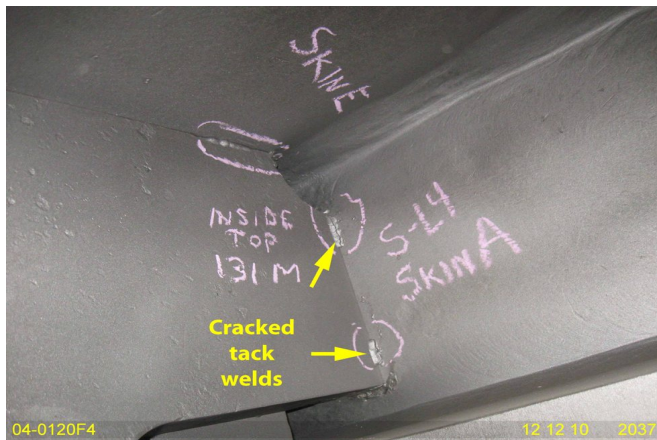
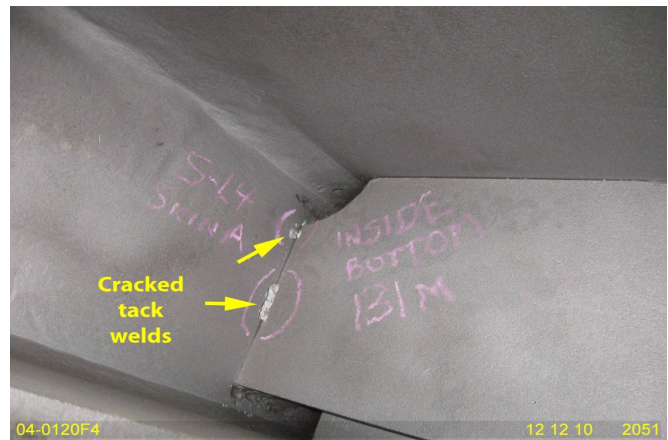
ZPMC requested Caltrans personnel to perform visual inspections of south tower, lift 4 from the top end at 146M elevation to the bottom of 130M double diaphragm. At approximately 2030 hours to 2130 hours, following the initial blast cleaning of the steel surfaces, several QA Inspectors, including this QA Inspector, performed random visual inspections of these areas. ABF and ZPMC Inspectors were present and performing visual inspections of the areas noted above. ABF Representative Xiao Jun Peng (BABF) and ZPMC QC Sun Zi Wang (BQC) informed this QA Inspector that they would be documenting all weld repairs and would provide this to the QA Inspectors with a copy of the documentation. This QA Inspector visually observed several areas that required grinding to resolve visual weld spatter, arc strikes, shallow nicks, scrapes, rough edges of unground welds, and sharp edges of ground welds. These areas were clearly marked with chalk as either “grind” or “grind and perform magnetic particle testing (MT)” using the letter G or the letters G+MT, respectively. This QA Inspector was notified that the above noted areas had been ground and MT had been performed. This QA Inspector randomly visually verified that the work had been performed. This QA Inspector observed 4 tack welds inside at the top and bottom of the 131M double diaphragm to skin A showing 2mm to 3mm cracks. BABF informed this QA Inspector that the areas needed to be clearly marked as needing to be ground off, MT performed, photographed, and documented. See photos below. Weld repairs were observed by other inspectors. All locations were documented by BQC and BABF. A copy of the documentation was presented to the QA Inspectors.
